Servicing / Technical bulletin number: 089

Date Issued: March 2025

Subject: Change to Crewsaver operating Head torque wrench

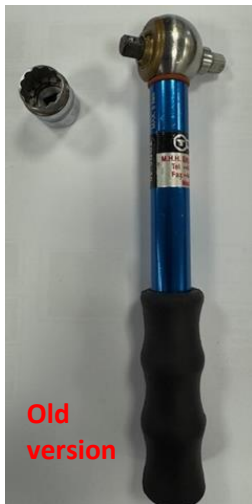
Old
version

The supplier of the calibrated torque wrench part code 10465 has stopped manufacture to this item.

The T-bar replaces the welded $\frac{1}{4}$ drive point on the head of the old tool, that was used to remove the nut from the UML and HR Heads.

NOTE. The old version tool is still approved to use and does not need to be changed.

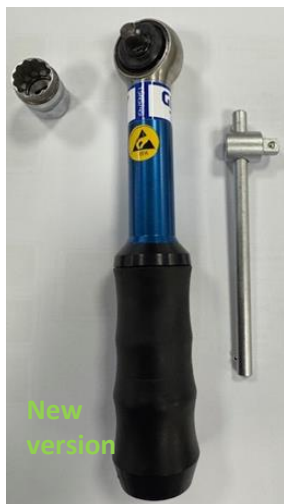
New
version

This has been replaced by a new version of the torque wrench and a T-Bar.

They will be supplied under the same Part code. (10465)

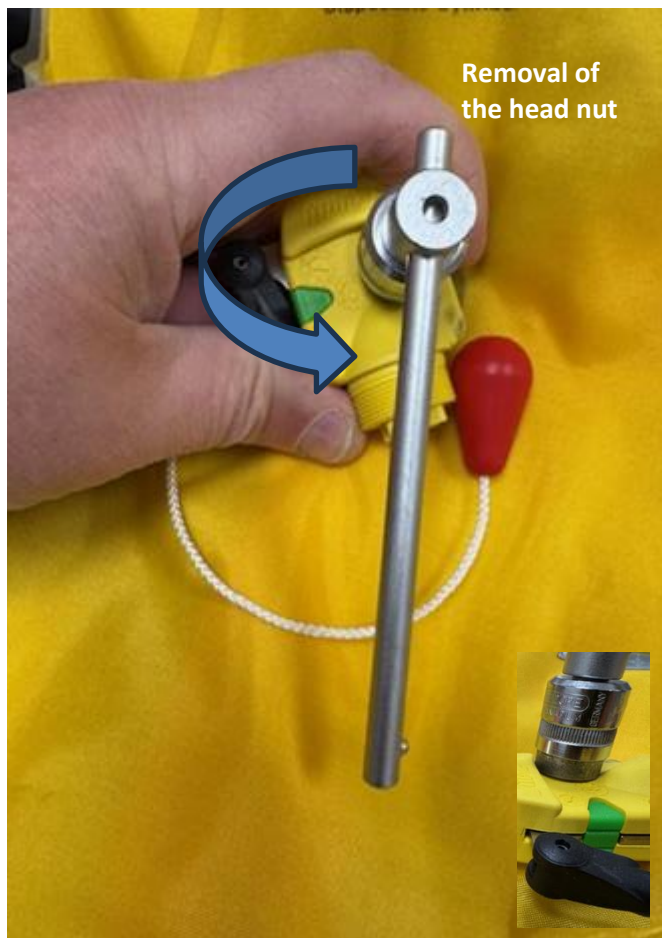
Modified socket

The New version tool is supplied with the modified socket which is required when removing the UML operating Heads (this must be used as a Standard socket can damage the nut.)

Please ensure the correct approved tools are used for removal and replacement of the operating head.
Failing to do this will result in damage to the lifejacket.
