- 1. This Service Manual refers specifically to the MIRG Elite Twin Lifejacket. It differs in a number of respects from the standard Crewsaver Elite lifejacket.
- 2. Diagrams 1 and 2 give a detailed parts explosion of the unfolded MIRG Elite showing the front and rear inflators. Diagrams 3 shows the front view of the folded jacket when in automatic mode and and Diagram 4 shows the front view when in manual mode. See point 6 below. Diagram 5 shows the rear view of the folded jacket. These drawings show the latest version of the MIRG Elite and may differ in some respects from earlier versions.

### MIRG ELITE UNFOLDED - FRONT INFLATOR

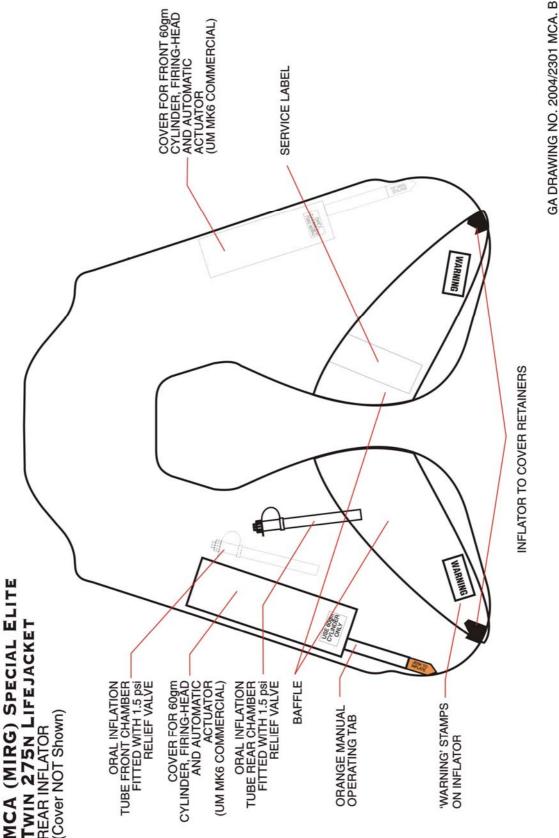
#### **DIAGRAM 2**

### MIRG ELITE UNFOLDED - REAR INFLATOR

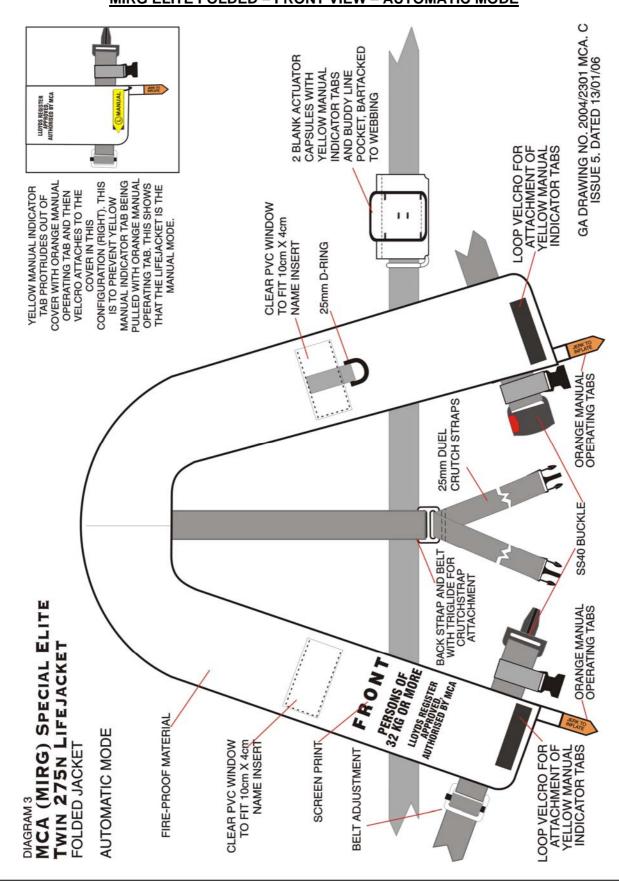
# <u>DIAGRAM 3</u> MIRG ELITE FOLDED – FRONT VIEW – AUTOMATIC MODE

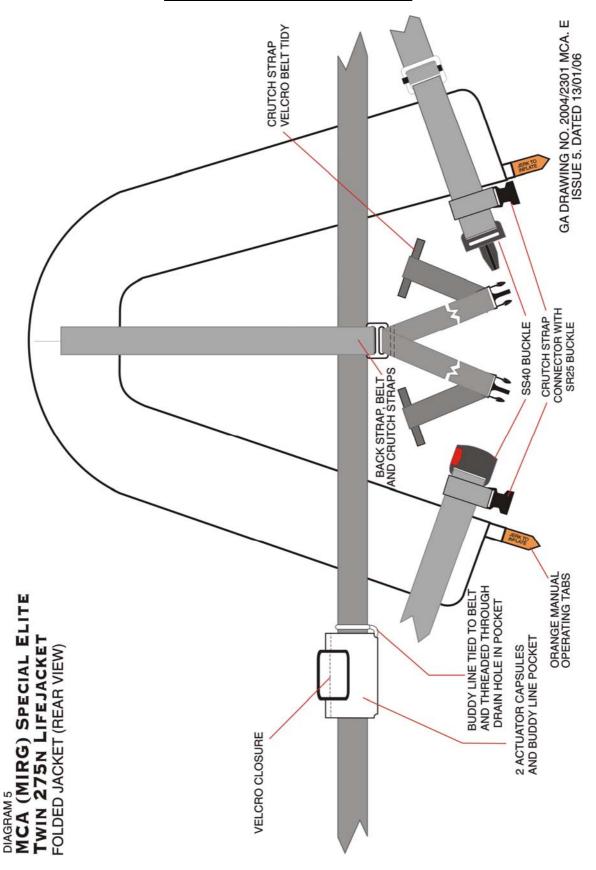
#### **DIAGRAM 5**

### **MIRG ELITE FOLDED – REAR VIEW**

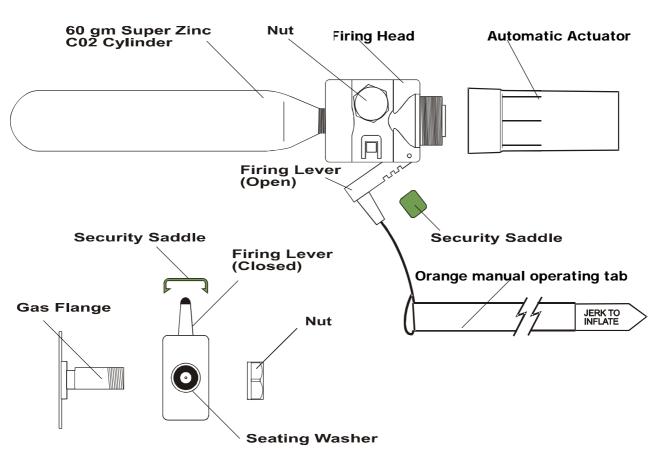
### Firing Head Mk 6

- 10. Examine the firing heads for signs of damage. Appendix 1 gives an exploded view of the Mk 6 firing head. The Mk. 6 firing head is green in colour. Test the operation of the firing heads by depressing the button at the opposite end of the cylinder entrance. Ensure that the pin travels forward and that both pin and button return to their original positions. If necessary, replace the security saddle on the Mk. 6 firing head. Replace any defective firing heads as detailed in Appendix 1. Please note that ONLY Mk. 6 firing heads may be fitted to this jacket. Ensure that the locking nuts holding the firing heads to the jackets are fitted correctly by checking with a torque wrench set to 23lbf in. Ensure that the firing heads are fitted with an extra length orange manual operating tab marked 'Jerk to Inflate'. Check the condition of the protective cover and replace if necessary.

- b) Firing heads: Remove the each firing head and check the Schraeder valve for tightness. If tightening does not solve the problem it may be necessary to replace the Schraeder valve. Refit the heads according to the instructions given in Appendix 1.

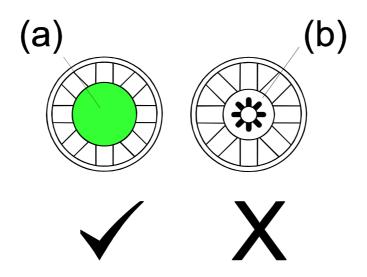
It is very important to check that the actuator has not been fired inadvertently. An unused actuator will show a green disc (a) in the bottom of the actuator. If a red dot (b) shows, **the actuator is no longer effective and must not be screwed onto the firing head.** If it is used in this condition it will activate the head and inflate the lifejacket. The Mk 6 automatic actuator is green in colour.

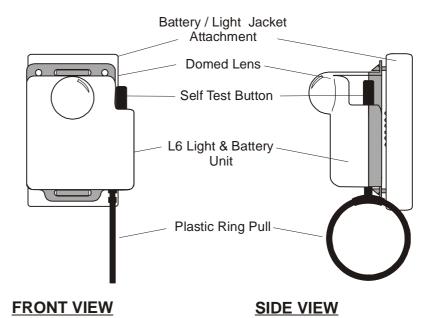
# PLASTIC FIXING BRACKET

The L6 light is shown below. To test this unit, press the manual activation point and then return it to its original position. The battery is date stamped and should also be replaced if the expiry date has been reached or if the expiry date is less than nine months from the date of service.

The light is fixed, by means of the plastic fixing bracket, to a strip of yellow material across the right front (when worn) of the opened jacket. The ring pull cord should be connected to the cord loop at the side of the jacket using a cable tie. Make sure that the cable tie is pulled as tight as possible.

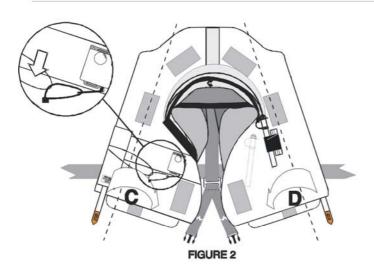
Ensure the oral inflation tube cap (a) is replaced on both oral inflation tubes (b), after deflating both chambers.

Fold back the bottom of both sides of the inflator A and B along the dotted lines shown in the diagram.

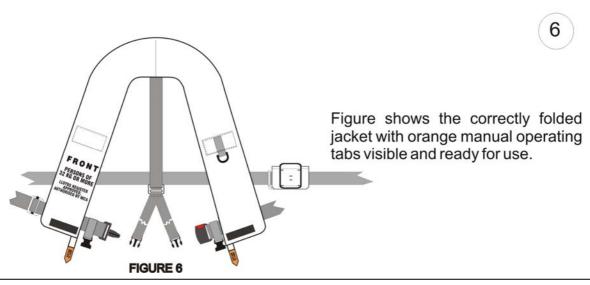
Fold the cover legs K and L over. Fasten zips by pulling the sliders up to the top of the zip and fasten the velcro tab. Then pull the zip sliders back down to close the zip. Fold the neck cover J over and attach Velcro.
